PROJECT SPOTLIGHT:

Engineering-Minded Die Cutter Finds Solution for Automotive Company in Panic Mode

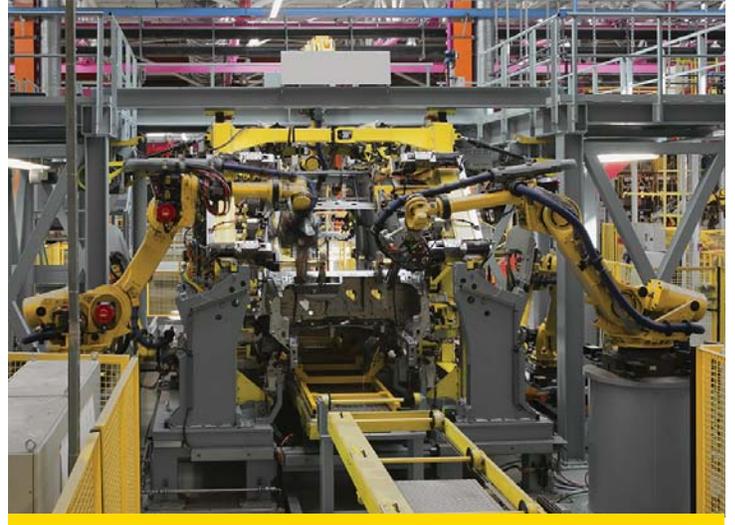
Years ago, a very irate automotive tier customer contacted the JBC team about a problem they were having with a die cut foam tape supplied by JBC. It was a long narrow piece of pressure sensitive adhesive backed urethane foam about ½" wide and four feet long. It was used as a seal along the top of a plastic injection molded vehicle cowl.

The customer noted that parts were literally falling off the cowl as they were being delivered into the automotive assembly plant. The customer made it clear that the situation was caused by JBC's faulty adhesive.

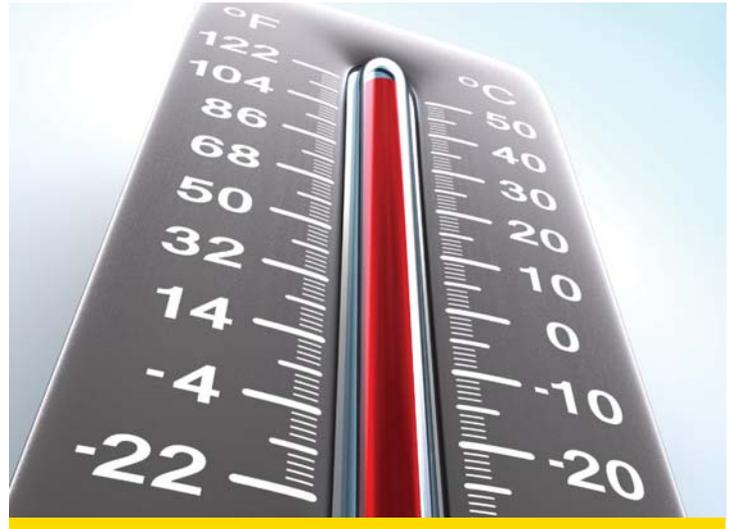
The cowl was molded with a specific polyolefin thermoplastic. The foam tape was adhered along the full length of the cowl which included several deep valleys.

The failures occurred exclusively at the base of the valleys. The plant that molded the part was air conditioned.

The analysis allowed JBC to formulate a theory that the real issue was plastic elongation caused by a dramatic temperature increase in August. The foam tape in the valleys that did not stretch was being mechanically lifted as the polyolefin cowl increased in length. It was analogous to laying a metal chain on the base of a valley then increasing the width of the valley. The chain literally lifts from the base and becomes a suspension bridge. The customer was provided JBC's theory and analysis with a simple test that could be conducted to validate the theory.
